Pest & Building Report

9 Chapman Street Moss Vale

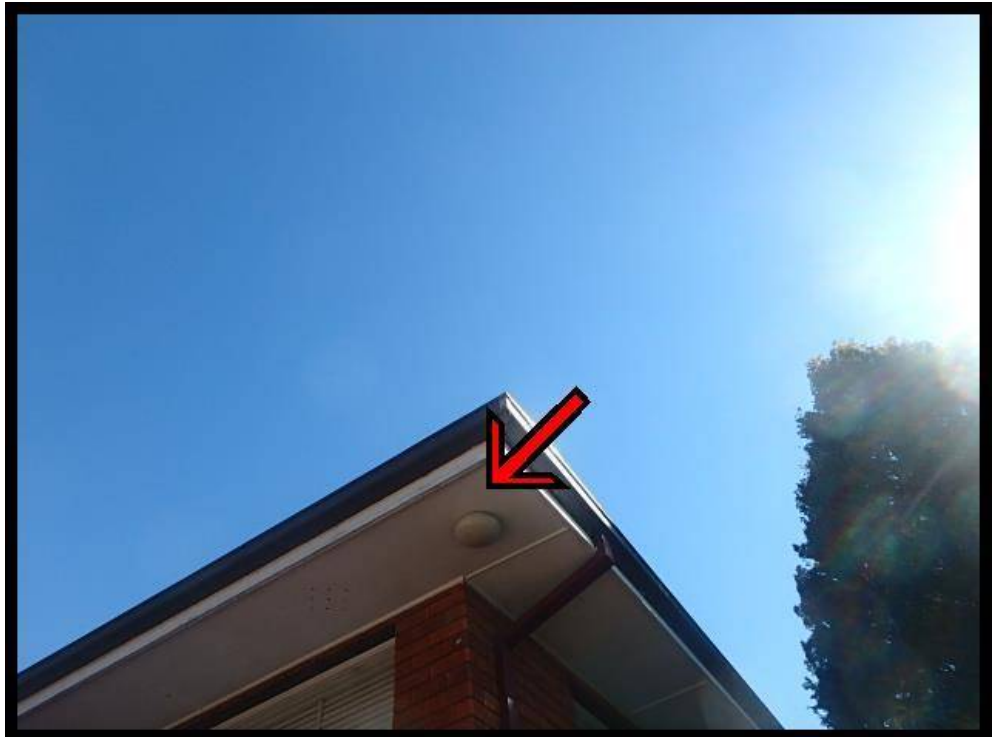
The eaves are lined with asbestos cement and/or fibre cement sheeting. The overall condition of the eaves lining is good.

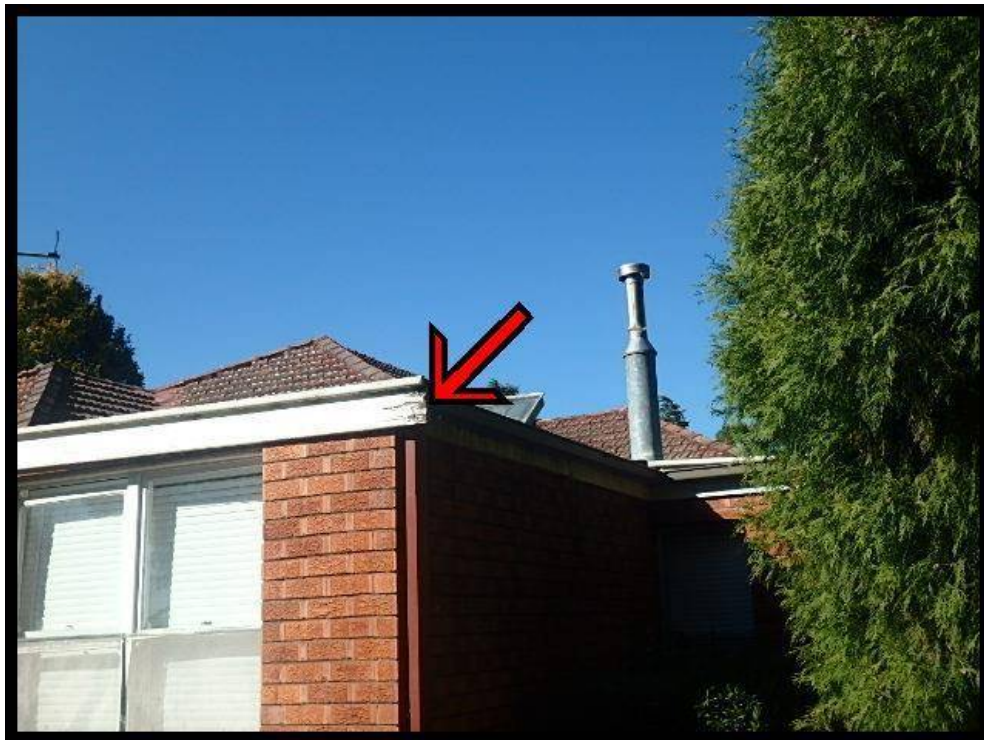
The overall condition of the fascias/bargeboards is fair. Minor wet rot decay is present to timber fascias and barge boards. The paint work is deteriorating and maintenance is required.

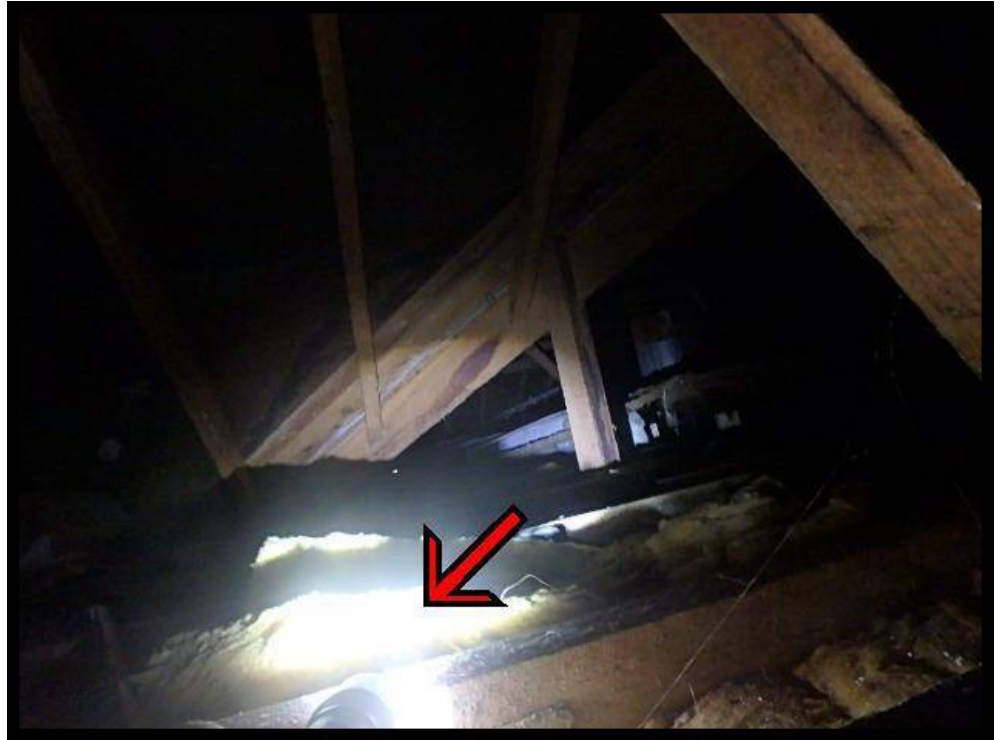
Inspection over the eaves was restricted due to the low pitch and construction allowing only a limited visual inspection from a distance to be carried out.

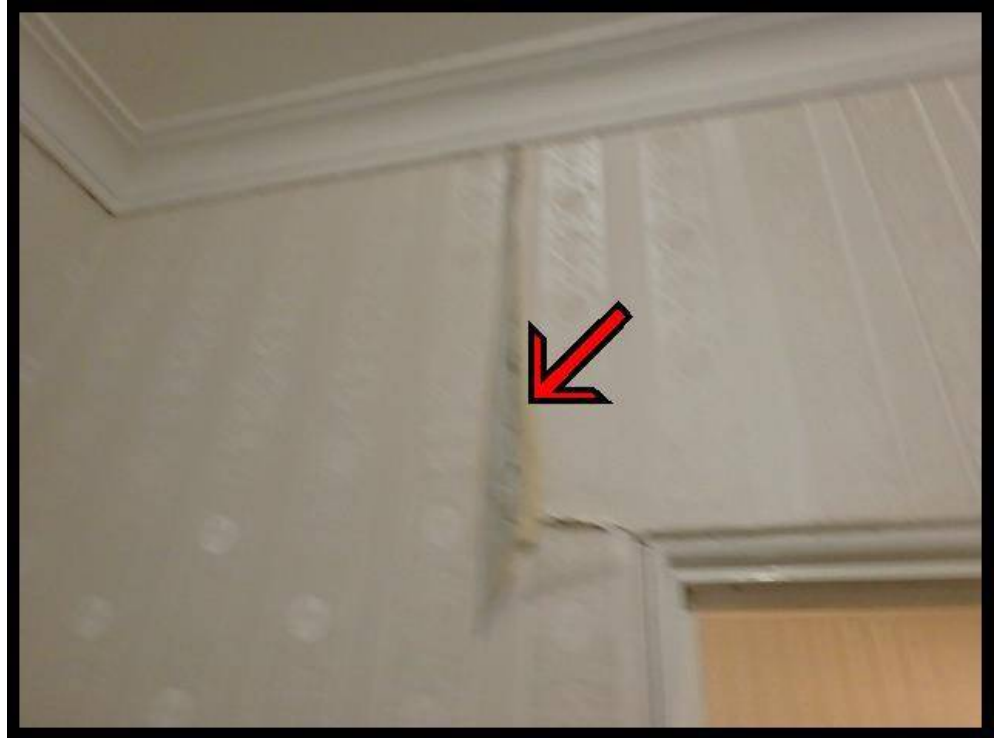
Cracks are evident. Visible cracking has been categorized as a serviceability defect. Cracking of a building element is a serviceability defect where in the opinion of the inspector the function of the building element is impaired however, the expected consequence of this cracking is unknown until further information is obtained.

Cracking can be expected in a building of this age and construction.

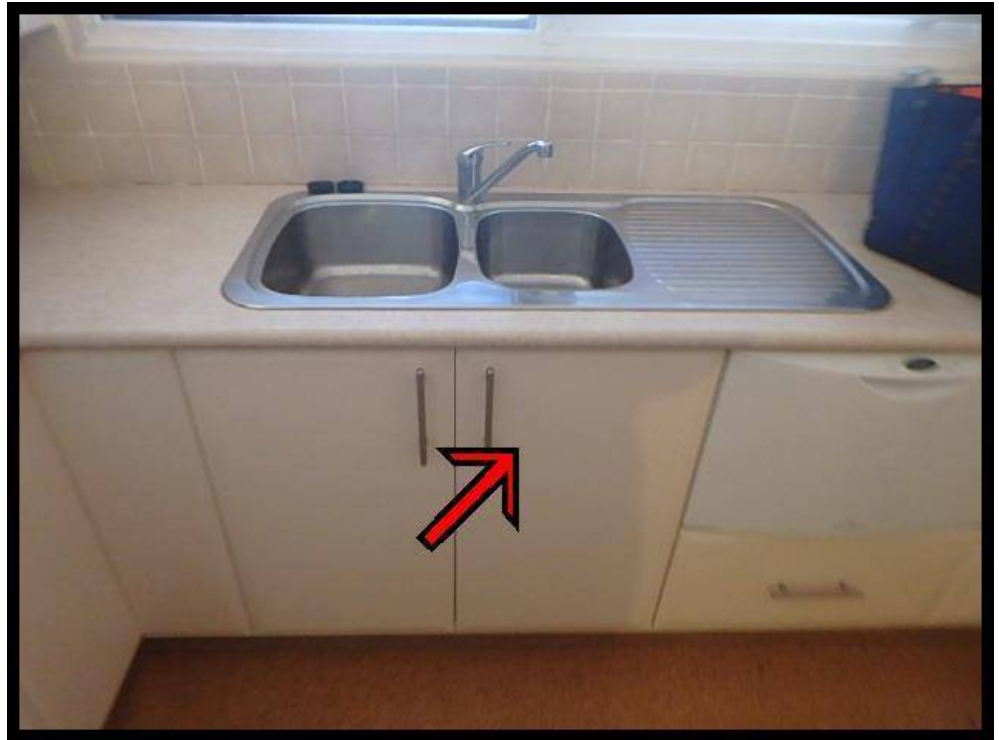
The condition of the fixtures is generally good.

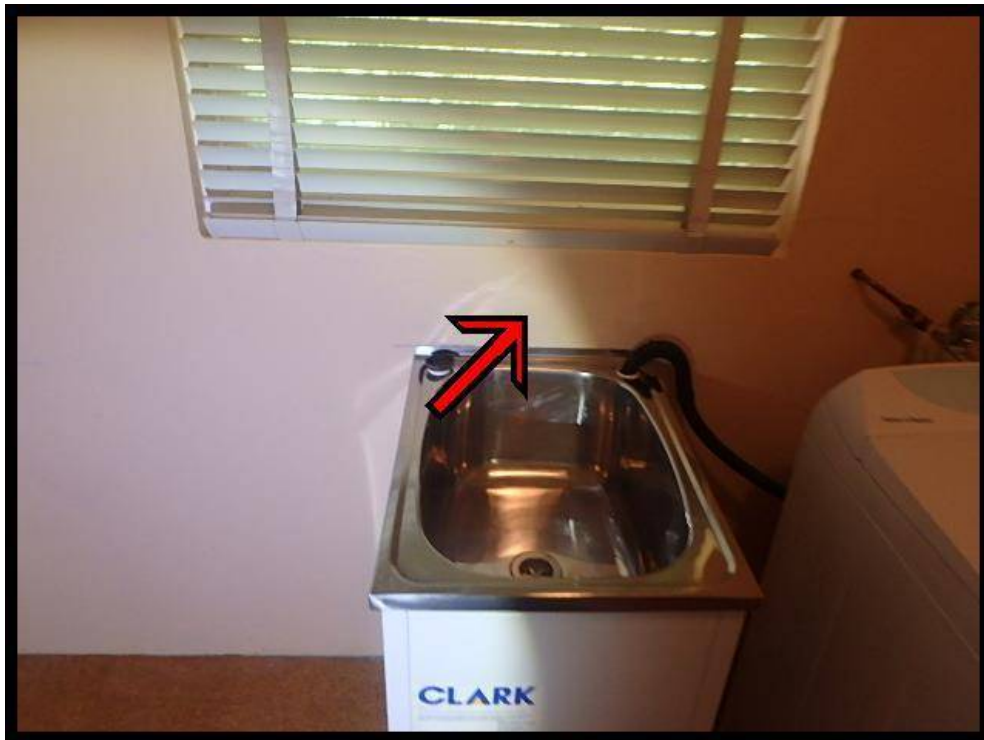
The tub and taps appear serviceable. A tile splash back is not present and should be fitted.

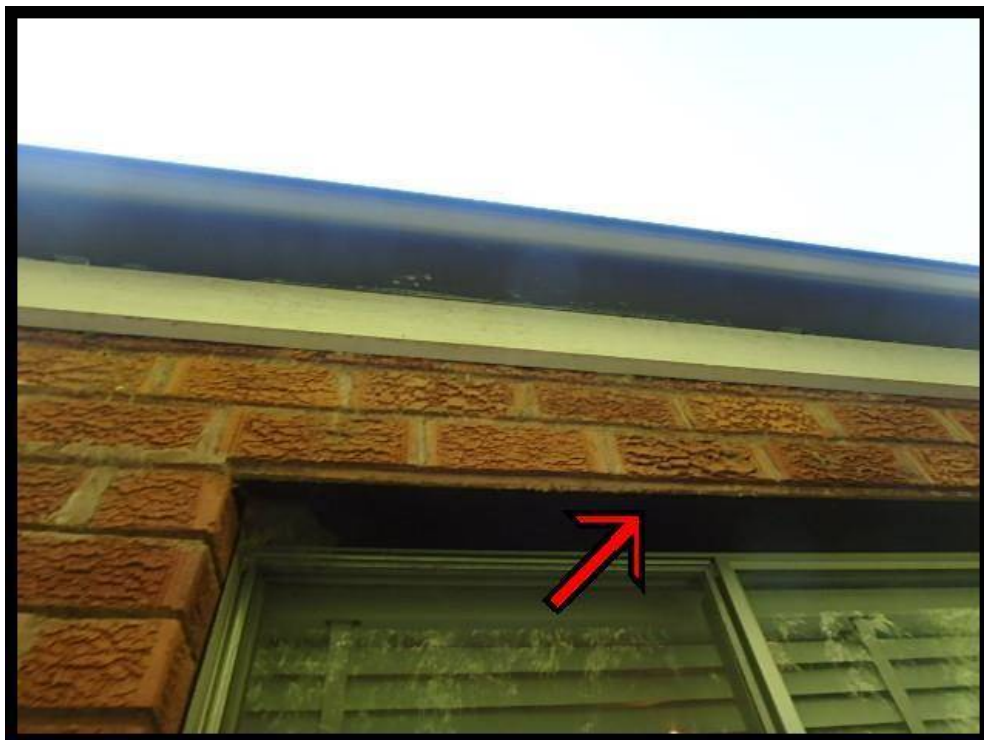
The lintels are of: Mild steel: Minor rust is evident to the steel in some lintels. This may reduce the service life of the lintels. This should be treated to prevent further deterioration.

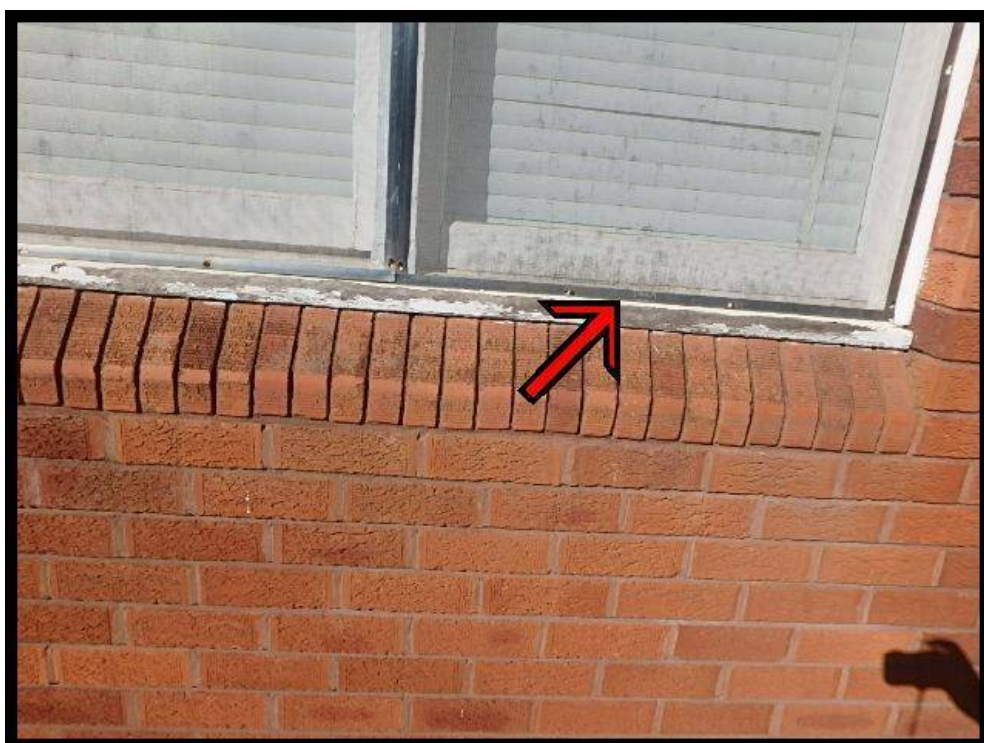
The condition of the exterior of the windows is generally fair. Paint is peeling off the window frames and maintenance is required.

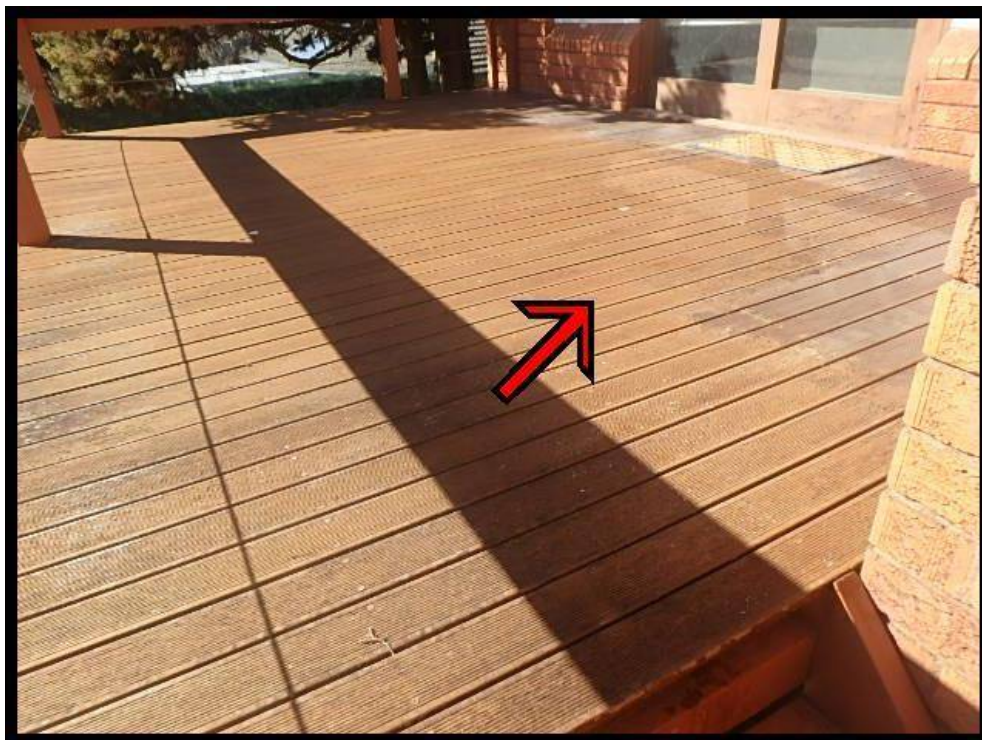
The decking timbers have been incorrectly installed, the groves allow water to pond and wet rot decay to develop.

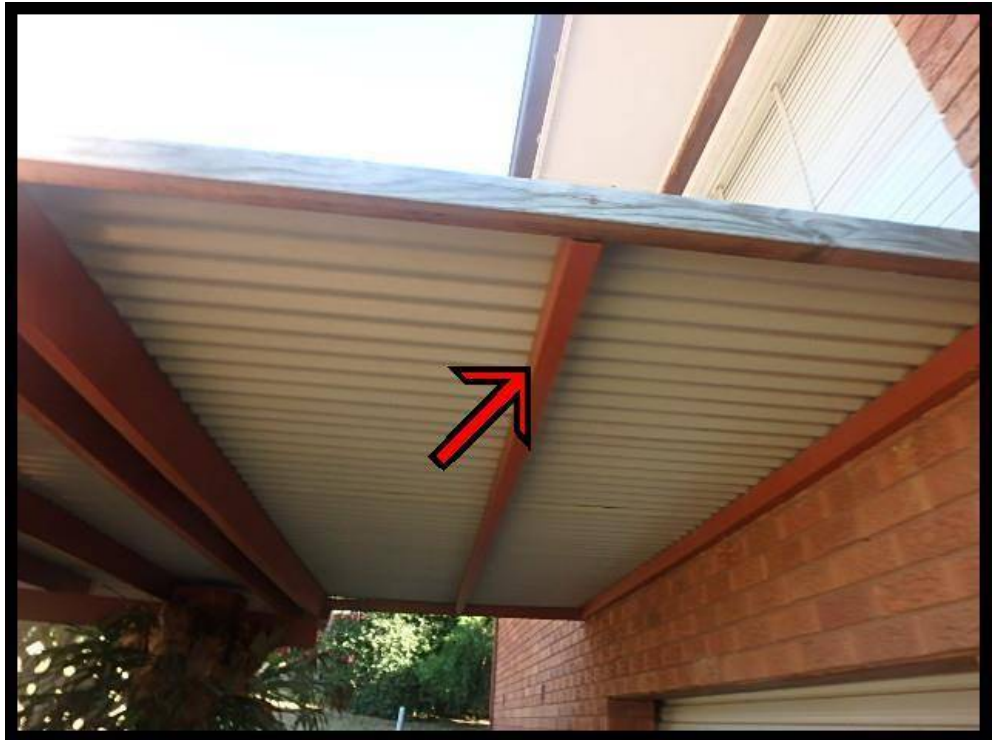
To the front of the main house.

Roof Construction: The roof is of skillion style construction.
Roof Covering: Corrugated steel:
Roof Covering Condition in Detail: The overall condition of the roof coverings is good.

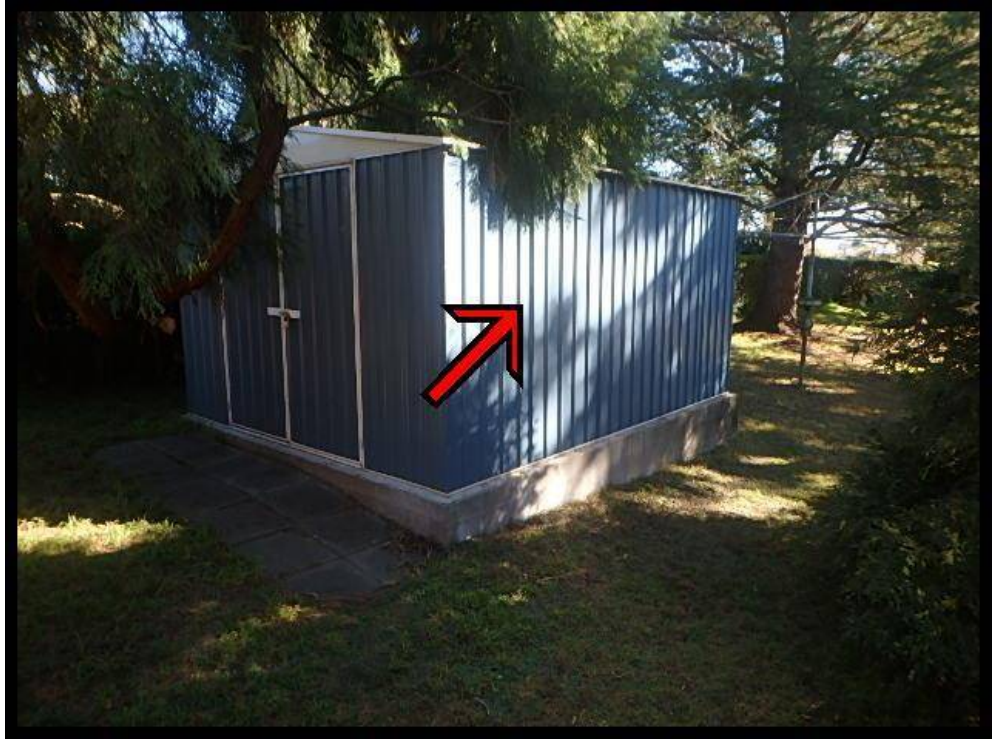
The structure is generally in good condition.

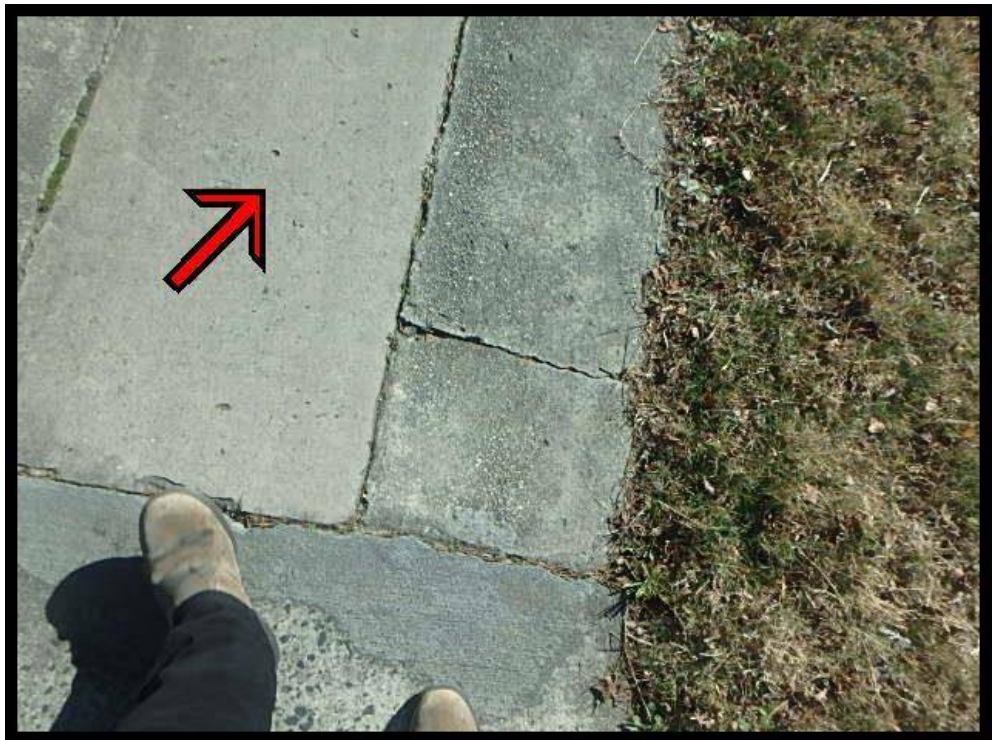
The concrete driveway stands in fair condition.

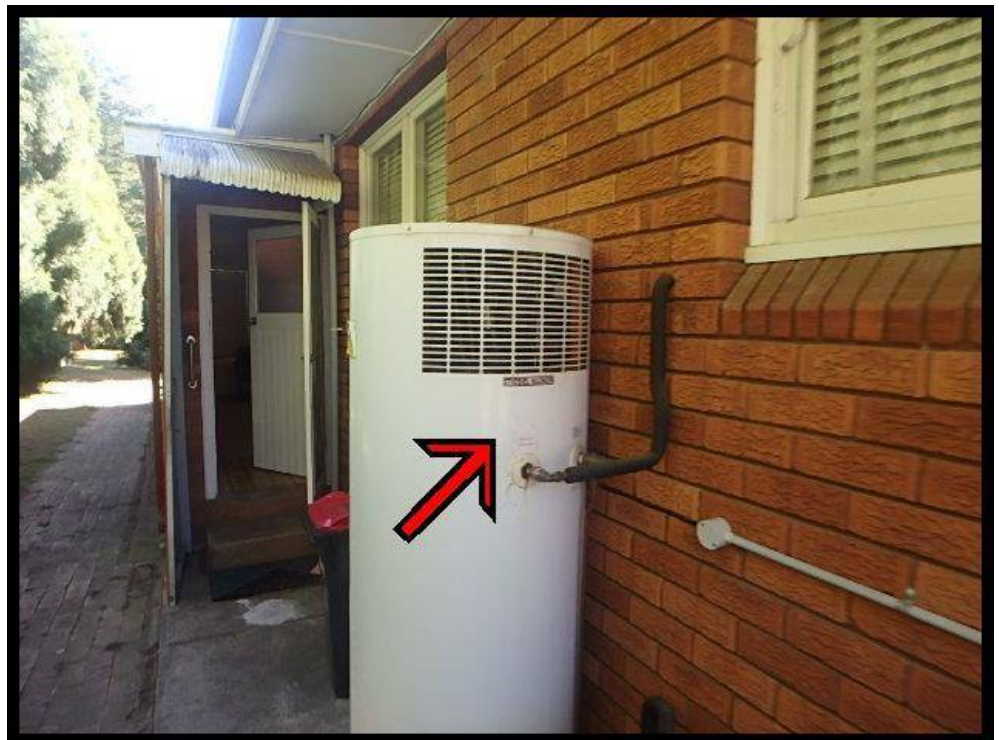
Mains electric hot water system: Mains pressure: Located externally: The hot water system appears to be in working condition. No specific tests other than running the hot water from a tap was carried out. No determination has been made as to the suitability or adequacy of the hot water system in relation to capacity or otherwise.
